DEPARTMENT OF TRANSPORTATION**DIVISION OF ENGINEERING SERVICES**

Quality Assurance and Source Inspection

Contract #: 04-0120F4Cty: SF/ALA Rte: 80 PM: 13.2/13.9File #: 1.28**WELDING INSPECTION REPORT****Resident Engineer:**Pursell, Gary**Address:** 333 Burma Road**City:** Oakland, CA 94607**Report No:** WIR-014779**Date Inspected:** 14-Jun-2010**Project Name:** SAS Superstructure**OSM Arrival Time:** 1100**Prime Contractor:** American Bridge/Fluor Enterprises, a JV**OSM Departure Time:** 1930**Contractor:** American Bridge/Fluor Enterprises, a JV**Location:** Job Site**CWI Name:** See Below**CWI Present:** Yes No**Inspected CWI report:** Yes No N/A**Rod Oven in Use:** Yes No N/A**Electrode to specification:** Yes No N/A**Weld Procedures Followed:** Yes No N/A**Qualified Welders:** Yes No N/A**Verified Joint Fit-up:** Yes No N/A**Approved Drawings:** Yes No N/A**Approved WPS:** Yes No N/A**Delayed / Cancelled:** Yes No N/A**Bridge No:** 34-0006**Component:** Orthotropic Box Girders**Summary of Items Observed:**

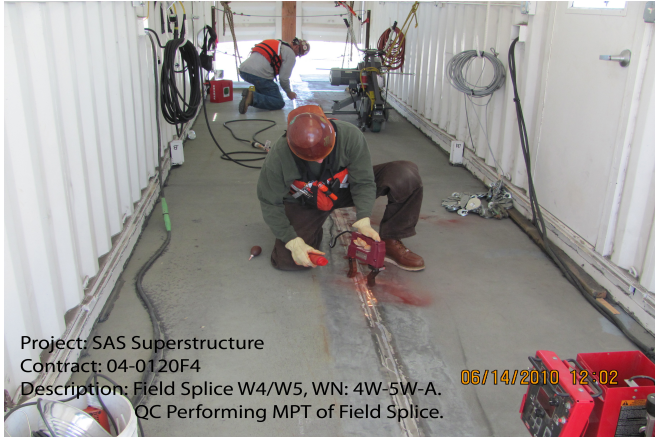
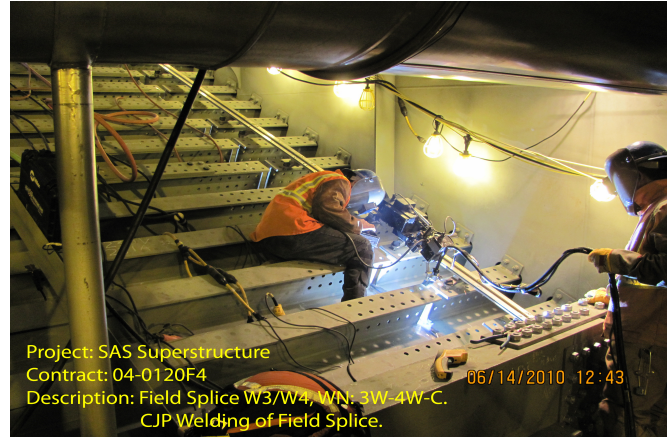
The digital photographs, below, illustrate the work observed during this scheduled shift.
